# Manhole Inspection Summary

Manhole # S37EE1037MH

Insp Date: **4/18/07 2:26 PM**

**Location** Address: **3807 GREENMOUNT AVE**

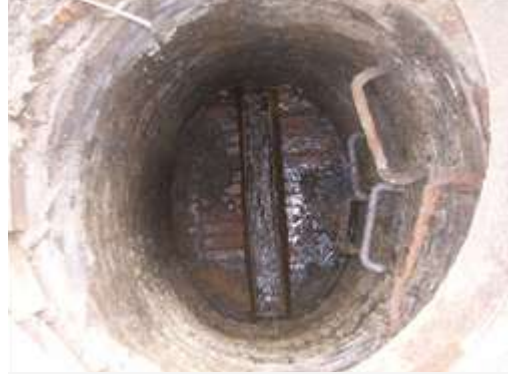
Top View

Corroded steps. Evidence of surcharge - Bench debris.

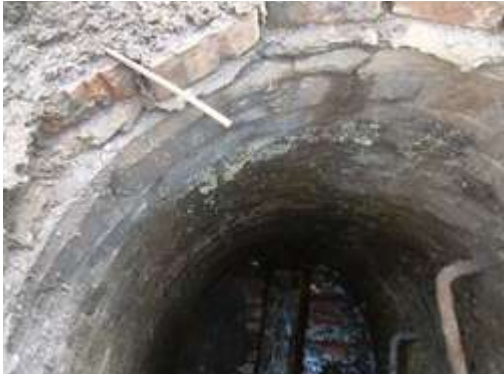
Defect

Frame offset. Corbel deterioration and infiltration. Barrel infiltration.

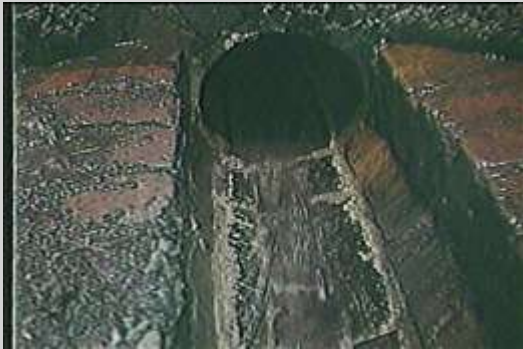
### 8 in. Circular Gravity Sewer Pipe Out @ 12 O'Clock

Channel deterioration.

Infiltration: **None** Pipe Seal Cond: **Cracked**

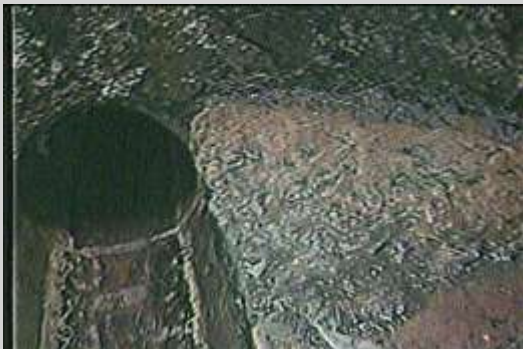
### 8 in. Circular Gravity Sewer Pipe In @ 6 O'Clock

Infiltration: **None** Pipe Seal Cond: **Unknown**
